GEOTECHNICAL CONSULTANTS

February 6, 2018  
Job No. 3245.3

Geotechnical Consultation  
Addendum 2 – Post Nuns Fire  
Lot S13, Sonoma Country Inn  
Kenwood, California

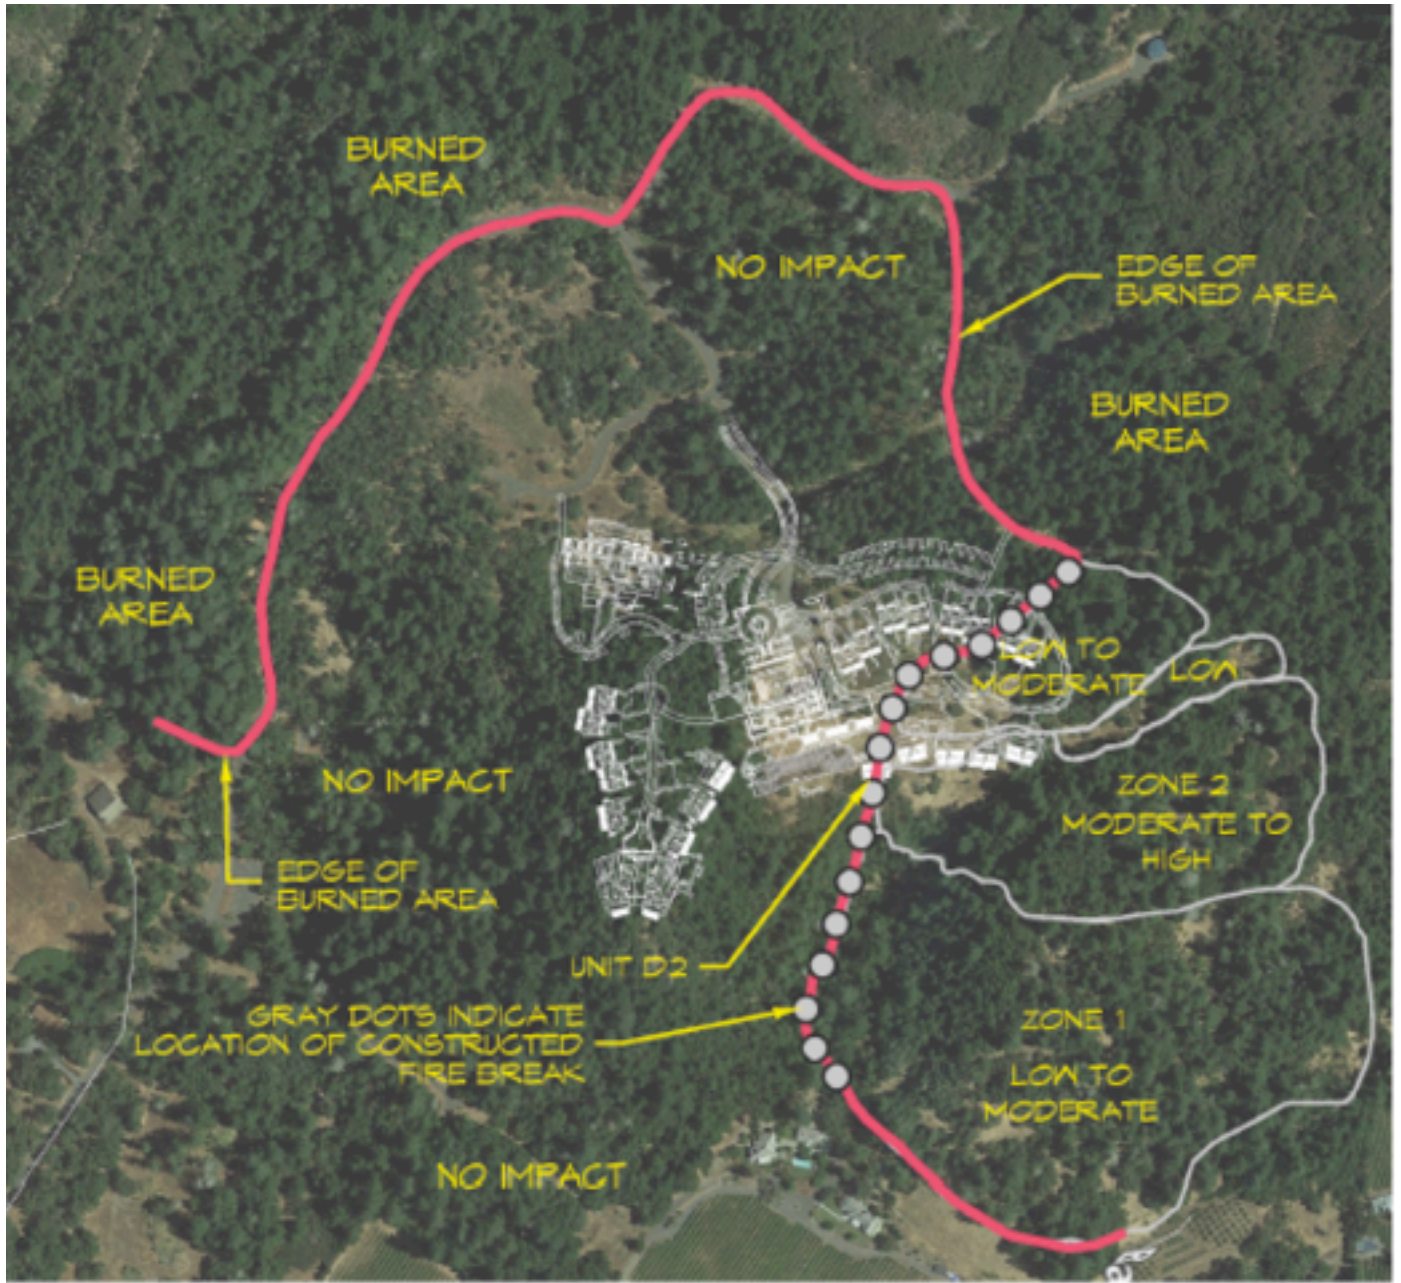
<b>BAUER ASSOCIATES</b>	Job No: 3245.3	<b>RESORT SITE FIRE PERIMETER MAP</b>	PLATE <b>2</b>
	Date: 1/18	LOT S13, SONOMA COUNTRY INN Kenwood, California	
GEOTECHNICAL CONSULTANTS	By: GDS

The *Resort Site Fire Perimeter Map* shown on Plate 2 indicates that the majority of the project site is within an unburned area. This was confirmed during our reconnaissance. The portion of the project site near the eastern project boundary, including portions of the on- and off-site drainage channel, were intermittently burned with low to moderate and moderate to high severity. Although we did not determine soil hydrophobicity (soils that repel water) at the site, it appears hydrophobic soil conditions may be present based on the presence of localized areas of burned grasses and trees. Adjacent areas encompassing Lots S7 through S11 appear to be scorched to moderately burned. Variable areas appear to

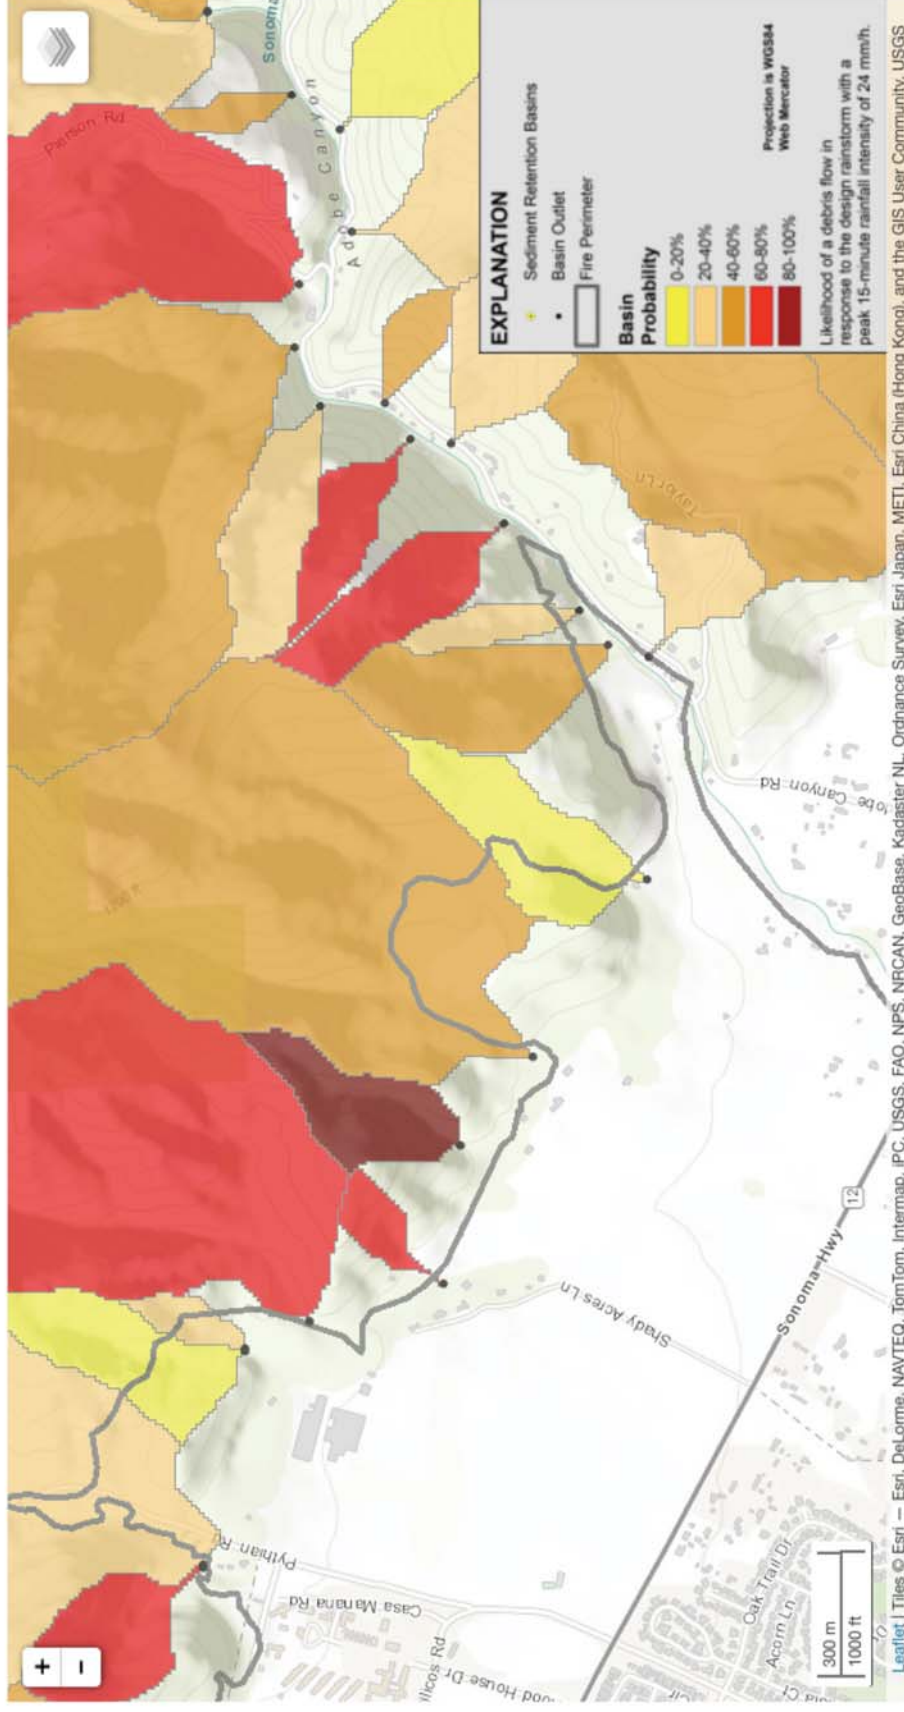
<b>BAUER ASSOCIATES, INC.</b> GEOTECHNICAL CONSULTANTS	Job No: 3245.3 Date: 1/18 By: GDS	<b>DEBRIS FLOW PROBABILITY</b> LOT S13, SONOMA COUNTRY INN Kenwood, California	PLATE <b>4</b>
---	---	--	-------------------

WERT (2017) contains Preliminary Hazard Assessment (PHA) maps that were prepared for estimates of the likelihood of debris flows, potential volumes, and combined relative debris flow hazard at fire-affected sites. At the project site (bench area), the PHA maps in WERT (2017) estimate the probability of debris flow hazard to be 40 to 60% with a hazard rating of moderate. At the drainage channel on the east, the PHA maps estimate the probability of debris flow hazard to be 20 to 40% on Lots S8/9, and 0 to 20% near the eastern parcel boundary. The PHA maps estimate the hazard rating of debris flow to be low. Portions of the PHA maps are shown on Plates 4 through 7.
